DEPARTMENT OF TRANSPORTATION**DIVISION OF ENGINEERING SERVICES**

Quality Assurance and Source Inspection

Contract #: 04-0120F4Cty: SF/ALA Rte: 80 PM: 13.2/13.9File #: 69.15**SOURCE INSPECTION REPORT****Resident Engineer:** Pursell, Gary**Address:** 333 Burma Road**City:** Oakland, CA 94607**Report No:** SIR-002511**Date Inspected:** 15-Jul-2010**Project Name:** SAS Superstructure**OSM Arrival Time:** 700**Prime Contractor:** American Bridge/Fluor Enterprises, a JV**OSM Departure Time:** 1900**Contractor:** Zhenhua Port Machinery Company, Ltd (ZPMC), Changxing Island **Location:** Shanghai, China**Quality Control Contact:** Mr. Don Walton**Quality Control Present:** Yes No**Material transfer:** Yes No N/A**Sampled Items:** Yes No N/A**Stock Transfer:** Yes No N/A**OK to Cut:** Yes No N/A**Rebar Test Witness:** Yes No N/A**Delayed/Cancelled:** Yes No N/A**Other:** Coating Inspection**Bridge No:** 34-0006**Component:** See Below**Bid Item:** 77, 78, 79**Lot No:** B #204**Summary of Items Observed:**

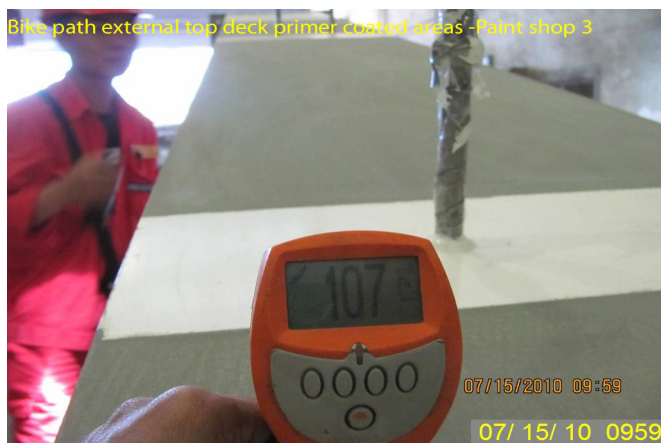
4. An inspection was requested on the OBG Bike path external Top deck primer coated areas -12 sets for Interzinc 22 -DFT Check, vide request no. 3690 at the Painting workshop no. 1, 2 & 3. This Caltrans inspector observed, ABF inspector Mr. Sun performing said inspection check. This was found accepted by ABF Inspectors after minor touch ups in marked areas. International protective coatings technical service representative was not found present during the course of this inspection process. (Photo attached)
